Mt. Carmel Dam Incident

Brad Benson
ND State Water Commission

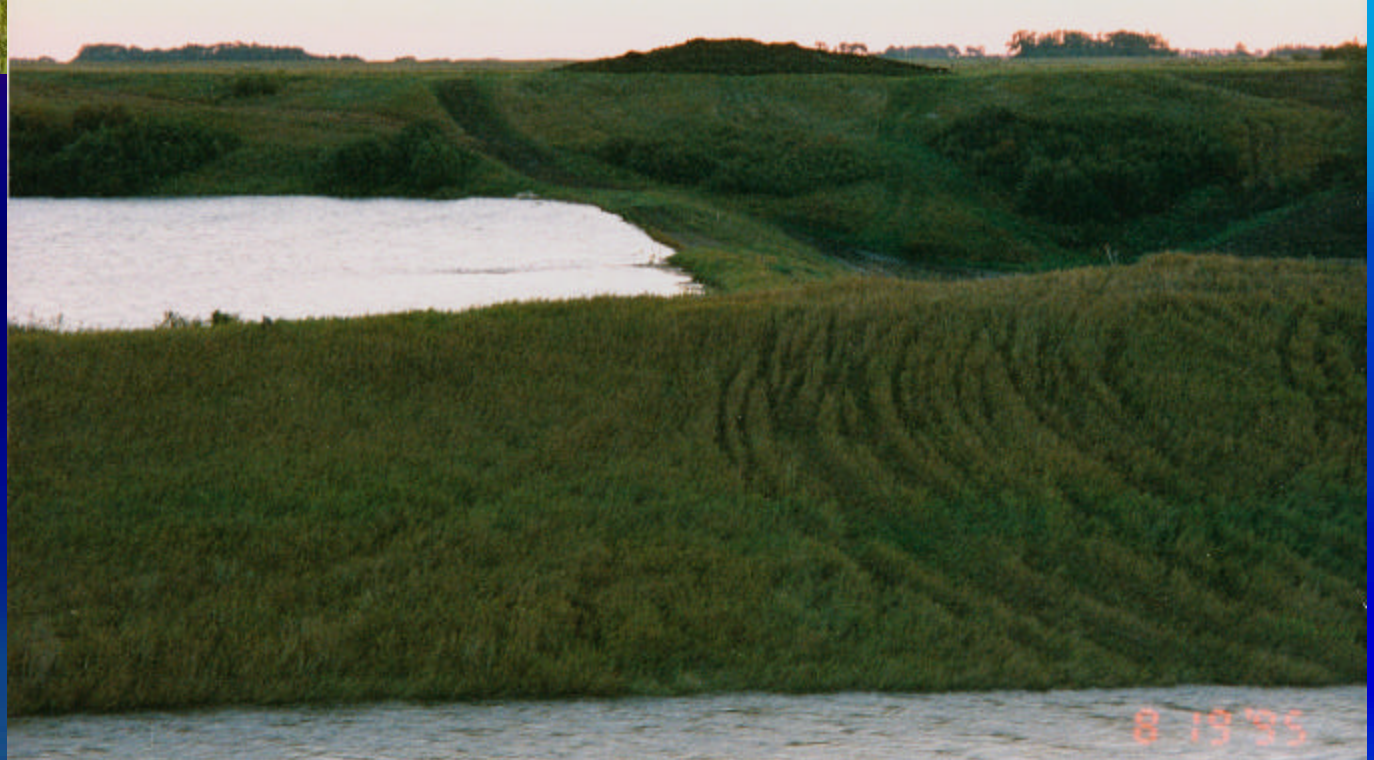
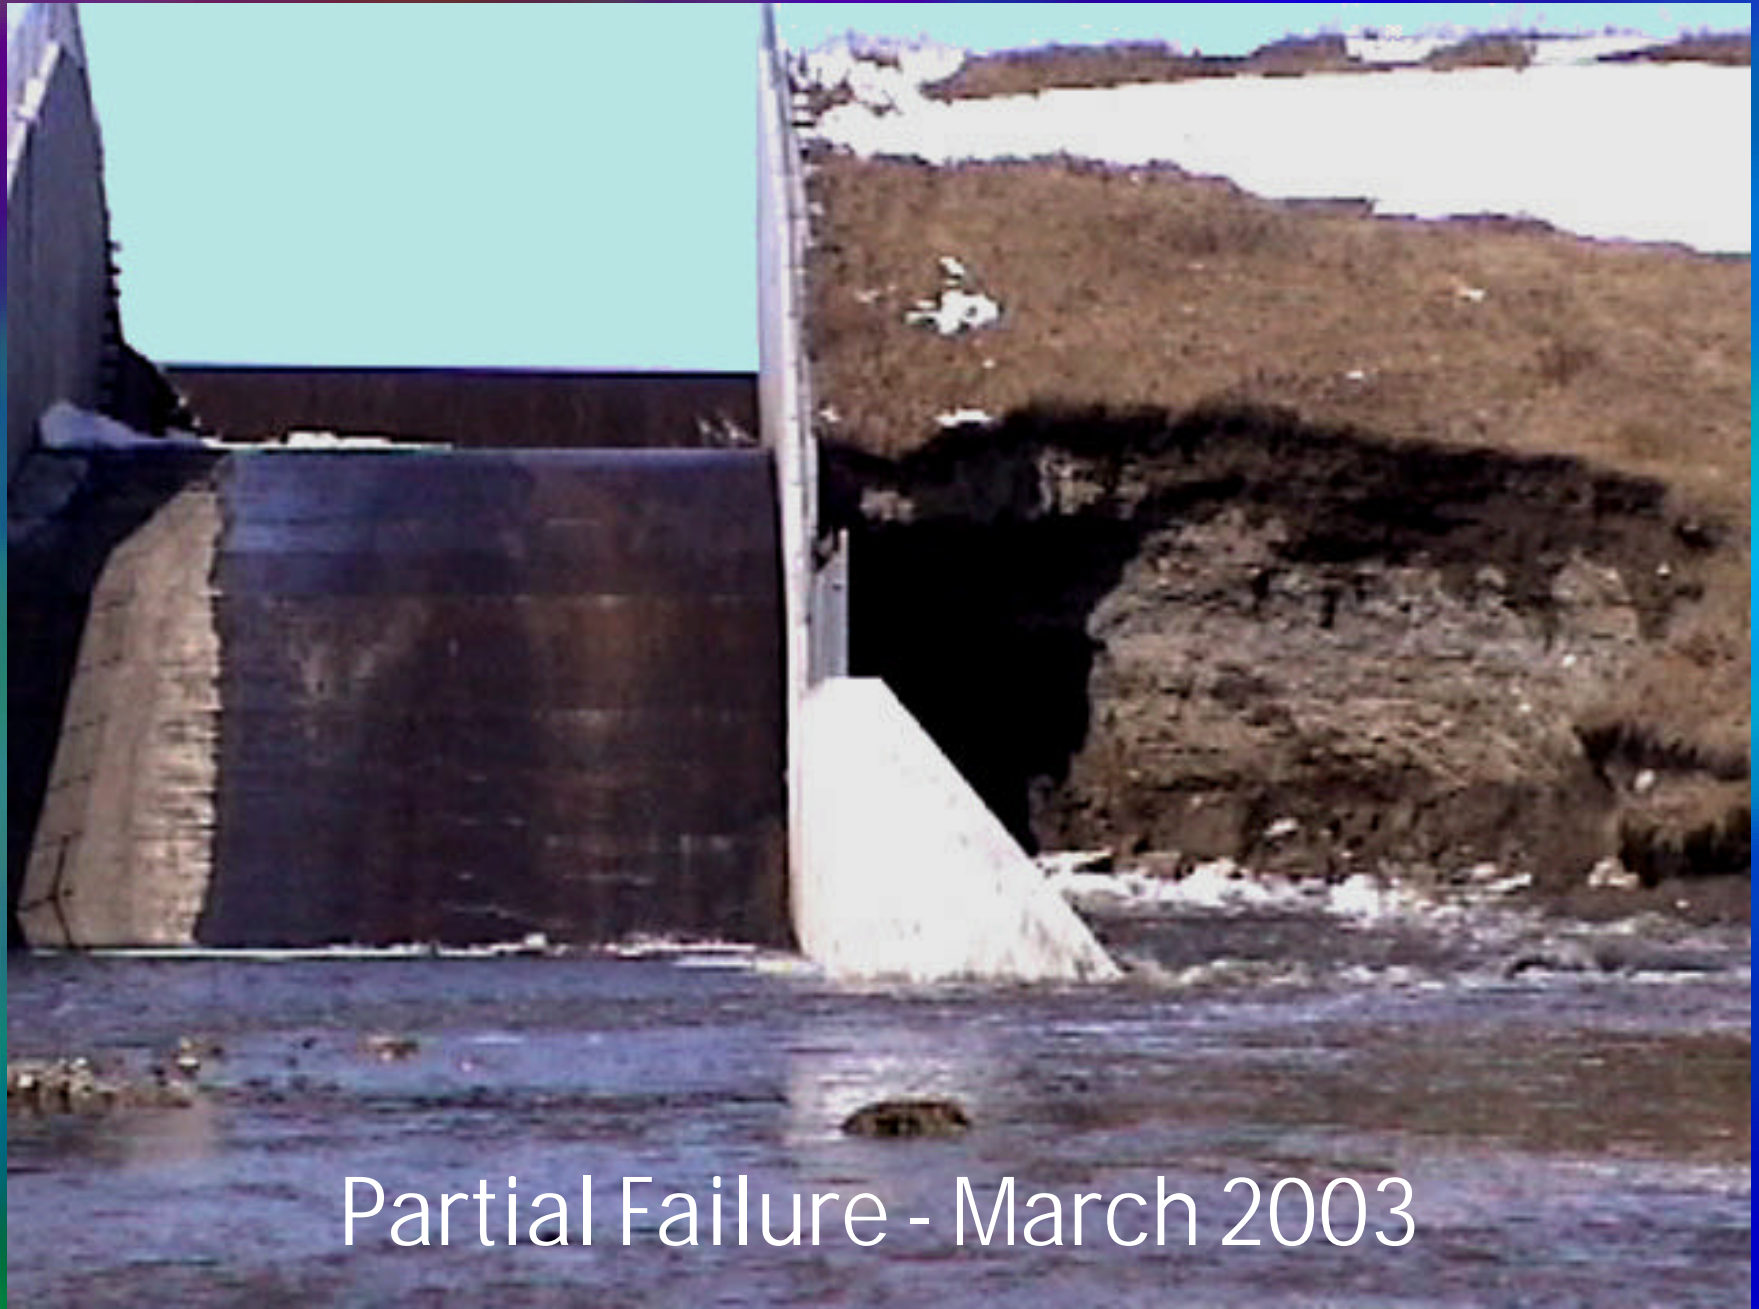
Rainfall Event
August 18, 1995

Before
←

After
→

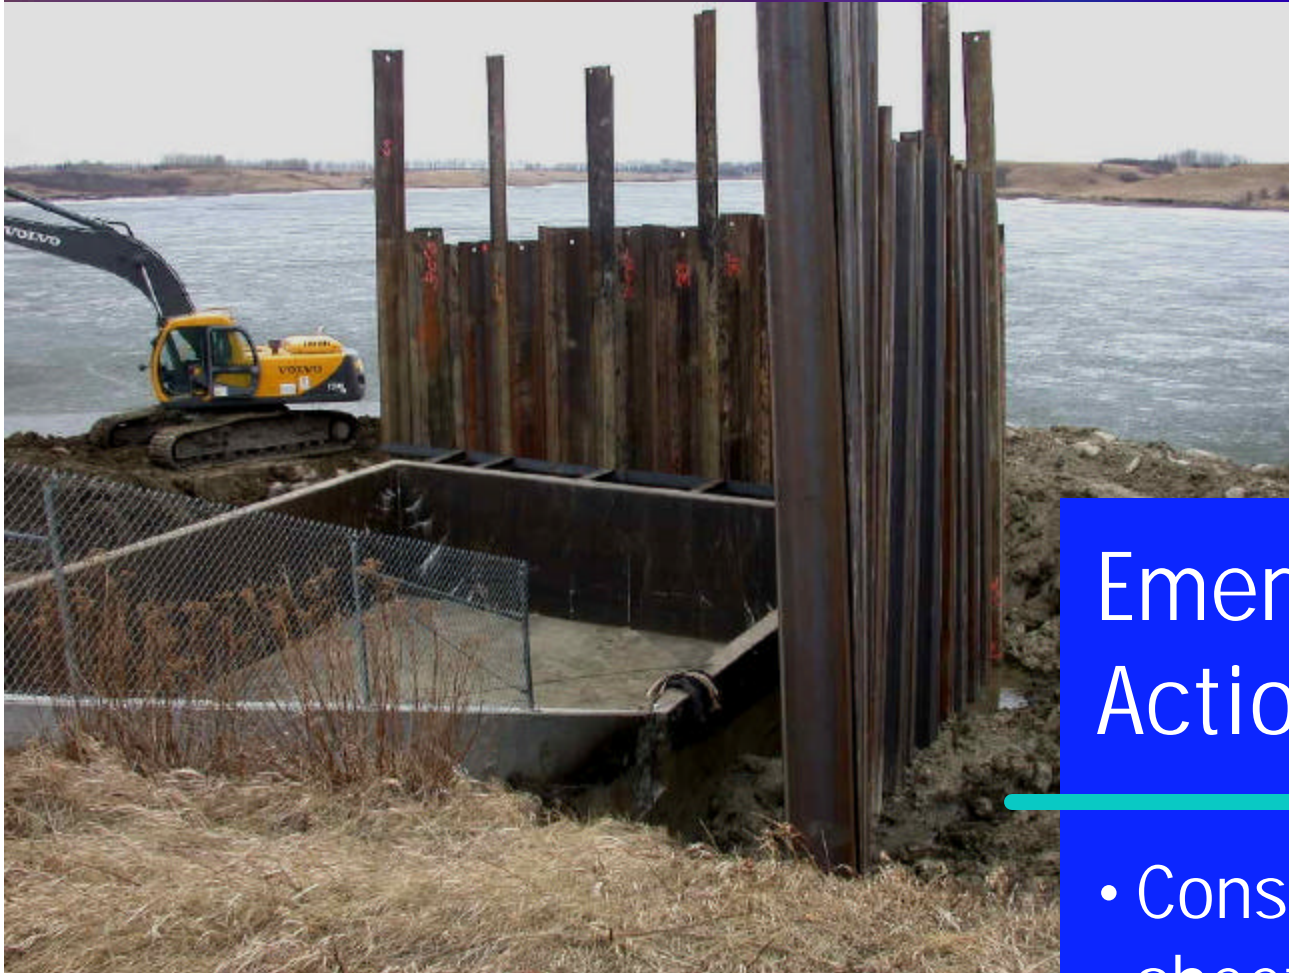
Partial Failure - March 2003

Emergency Actions Taken

- Construction of sheet-pile cutoff wall
- Removal of concrete headwall from 66-in. diameter concrete pipe
